**Flood Control Project Maintenance
Levee Inspections**
LMA District Cover Sheet
Spring 2020 Levee Inspection Results

Sacramento Maintenance Yard Sacramento Bypass

Levee Inspection Report By Mile - Spring 2020

Waterway	Bank	Unit Miles	Inspection Start/End	Inspector
Unit No. 01 Sacramento Bypass or North Levee	Right	1.74	04/07/2020 04/07/2020	Zach Jojola

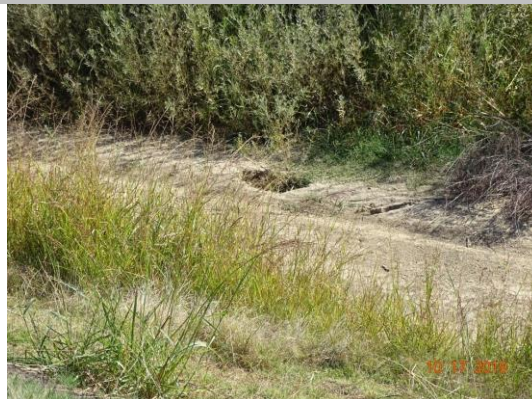
Photo 1 of 1 : SP_2020_ST0008_284_9_20200228_00003.jpg

LM Start	0.87	Rating **	A/W	Issue No.	9
LM End	0.87	Issue Type +	Ma	Location *	WS
Category	Earthen Levee			GPS Latitude/Longitude	
				Start	End
Item	Animal Control			38.602871 °	38.602871 °
				-121.574960 °	-121.574960 °
DWR ID	DWR_ST0008_01_f_2018_9				
Comment Code					
A3 : No rodents visible, but rodent burrows visible; need to backfill and compact or grout burrows.					
Inspector Comment					
There possibly is a beaver den on the edge of the waterside berm. It is not within the levee prism. Recommend monitoring for activity.

View of the hole on the waterside toe road. Fall 2019.

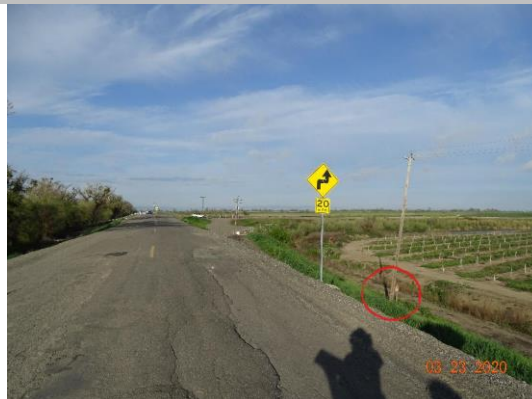
Photo 1 of 3 : UCIP_SP_2020_56647_83663.jpg

Comment Code						
Inspector Comment						
DS_ID:19068 FS_ID:56647 EP_NO: 17254 Repair Type: Non-Urgent Crossing Status: Indicator Found UCIP Comments: 03/23/2020 Record upgraded to Non-Urgent due to conflicting/missing contact information of owner on warning sign. Need to follow up with owner. Only 1 of previously 2 cable signs present on the LS. Otherwise, no issues observed during inspection. Verify if Permit No. 17254 applies only to associated crossing on Unit 2. Crossing is subject to relocation within the next 1 – 2 years due to the upcoming Lower Elkhorn Basin Levee Setback (LEBLS) Project. (S. Donovan - DWR UCIP) 10/04/2012 2 cable indicators/signs found on LS. (P. Amatya - DWR UCIP) FIELD_STRUCT_DESC: 6-inch high-density polyethylene (HDPE) casing containing three 1.5-inch fiber optics conduits across and bored under the left (south) bank levee of the Sacramento Bypass and under the U.S. Army Corps of Engineers slurry wall, at an unknown depth. (6-inch casing and three 1.5-inch conduits authorized under Permit No. 17254, 2000 - American Telephone and Telegraph Company [AT&T]). Permit No. 17254 authorized the removal of existing fiber optic conduits authorized under Permit No. 14673 and the relocation of three 1.5-inch conduits and their 6-inch HDPE casing from HLM 1.10 to HLM 1.12 on Levee Unit 2. (5-inch steel conduit containing fiber optic communication cable bored under the channel and both levees of the Sacramento Bypass [HLM 1.15 Unit 1 and HLM 1.10 Unit 2] at an unknown depth authorized under Permit No 14673, 1987 - American Telephone and Telegraph Company [AT&T]). FS Date: 3/23/2020 7:16:00 AM

Overview of the levee crown looking d/s with cable sign on the LS.

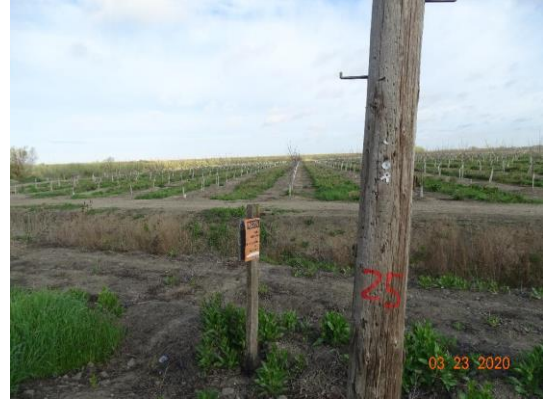
Photo 2 of 3 : UCIP_SP_2020_56647_83664.jpg

LS view: Cable sign near the levee toe.

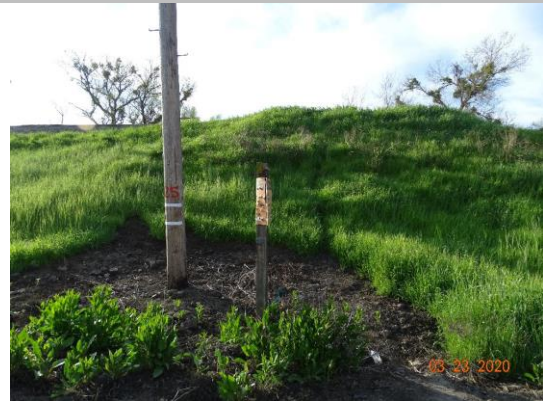
Photo 3 of 3 : UCIP_SP_2020_56647_83665.jpg

LS view: Levee slope viewed from the toe.

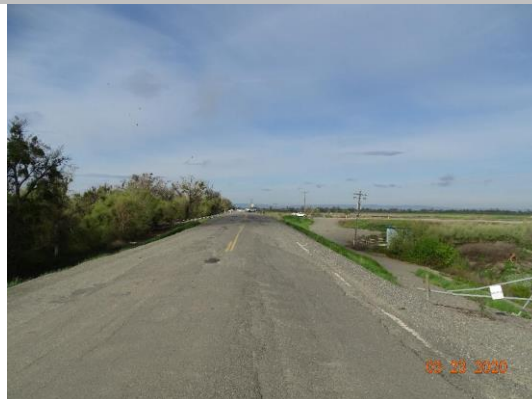
Photo 1 of 3 : UCIP_SP_2020_56574_83668.jpg

Comment Code						
Inspector Comment						
DS_ID:19076 FS_ID:56574 EP_NO: N/A Repair Type: Non-Urgent Crossing Status: Indicator Found UCIP Comments: 03/23/2020 Record upgraded from No Action Needed to Non-Urgent due to missing permits authorizing crossing and abandonment. Crossing is subject to relocation within the next 1 – 2 years due to the upcoming Lower Elkhorn Basin Levee Setback (LEBLS) Project. (S. Donovan - DWR UCIP)10/04/2012 A concrete saddle found on slough/drainage. No pump was found on LS and no structure/pipe found on WS. P. Amatya - DWR UCIP) FIELD_STRUCT_DESC: 36-inch corrugated metal drainage pipe through the levee, at an unknown depth. Grouted in place. Remains of concrete structure found on the landside (LS). [Additional References: USACE Sacramento O&M Manual Unit 122 - North Levee of Sacramento Bypass - Part 1, August 1955, revised 29 December 2016 (RM 174), USACE As-Built Drawing No 50-10-2796, Sheets 2 and 3 pdf file, April 1951]. FS Date: 3/23/2020 9:39:00 AM

Overview of the levee crown looking d/s.

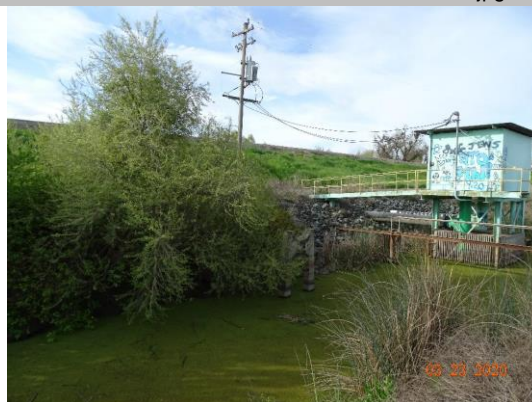
Photo 2 of 3 : UCIP_SP_2020_56574_83671.jpg

Overview of the LS.

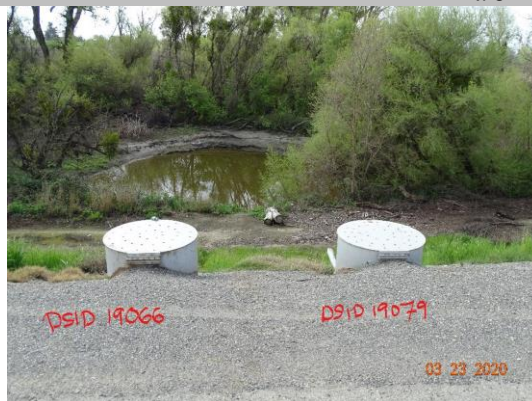
Photo 2 of 3 : UCIP_SP_2020_56649_83676.jpg

WS view: Siphon breaker.

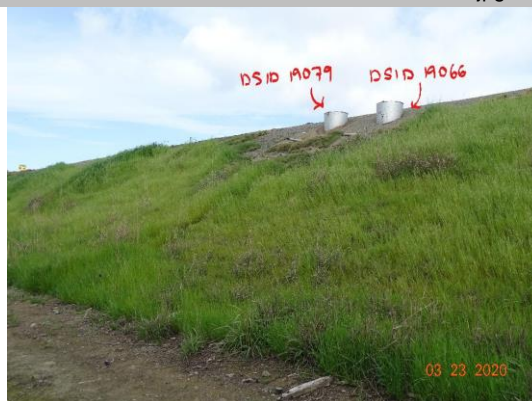
Photo 3 of 3 : UCIP_SP_2020_56649_83677.jpg

WS view: Siphon breaker and air vent on the levee slope.

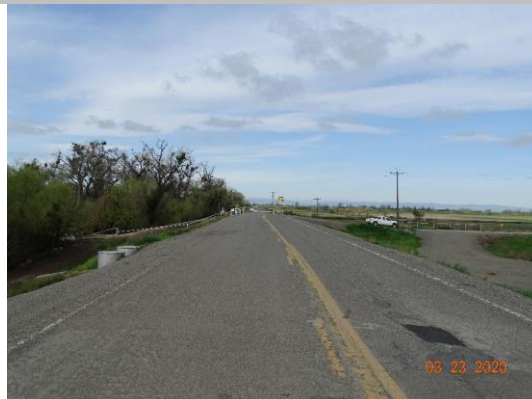
Photo 1 of 1 : UCIP_SP_2020_56576_83674.jpg

Comment Code						
Inspector Comment						
DS_ID:810 FS_ID:56576 EP_NO: N/A Repair Type: Non-Urgent Crossing Status: Not Found UCIP Comments: 03/23/2020 Record upgraded to Non-Urgent. Geophysical study (07-20-2018) found no evidence of the pipe. Crossing is subject to relocation within the next 1 – 2 years due to the upcoming Lower Elkhorn Basin Levee Setback (LEBLS) Project. (S. Donovan - DWR UCIP)10/04/2012 Not Found, Installed. (P. Amatya - DWR UCIP) FIELD_STRUCT_DESC: 36-inch concrete culvert through the levee, 28.0 feet below crown. A 24-inch pipe is sleeved through the culvert with the annular space grouted. A screw gate is in the concrete well on the waterward shoulder. (R.D. 537 pumping plant). [Additional Reference: DWR Levee Log, 2004 (HLM 1.10)]. FS Date: 3/23/2020 10:27:00 AM

Overview of the levee crown at assumed location of crossing looking d/s.

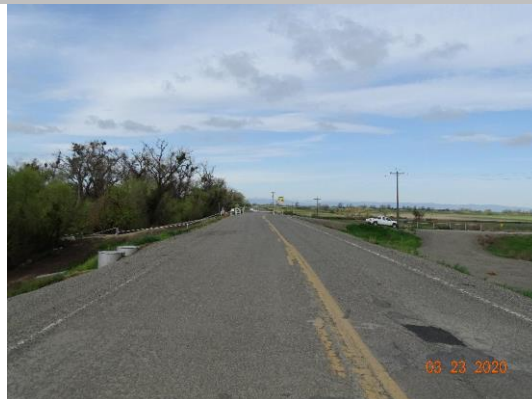
Photo 1 of 3 : UCIP_SP_2020_56577_83682.jpg

Comment Code					
Inspector Comment					
DS_ID:19079 FS_ID:56577 EP_NO: 13616 Repair Type: Non-Urgent Crossing Status: Found UCIP Comments: 03/23/2020 Record remains Non-Urgent due to erosion of the WS levee slope below the air vent (some cobble rock protection present) and erosion below the riser. Recommend further erosion repair. Crossing is subject to relocation within the next 1 – 2 years due to the upcoming Lower Elkhorn Basin Levee Setback (LEBLS) Project. (S. Donovan - DWR UCIP)10/04/2012 Horizontal Air vent on waterside slope. Green vegetation and depressions also found on waterside slope. (P. Amatya - DWR UCIP) FIELD_STRUCT_DESC: [Agricultural Drainage Pumping System] 2 of 2: 20-inch concrete encased steel discharge pipeline through the right bank (north) levee of the Sacramento Bypass, 6.33 feet below the crown. Siphon breaker on the waterside (WS). Vertical galvanized iron pipe trash rack on the inlet structure. (24-inch and 20-inch pipeline authorized under Permit No. 13616, 1995 - Reclamation District No. 537 [revised]). FS Date: 3/23/2020 2:28:00 PM

Overview of the levee crown looking d/s.

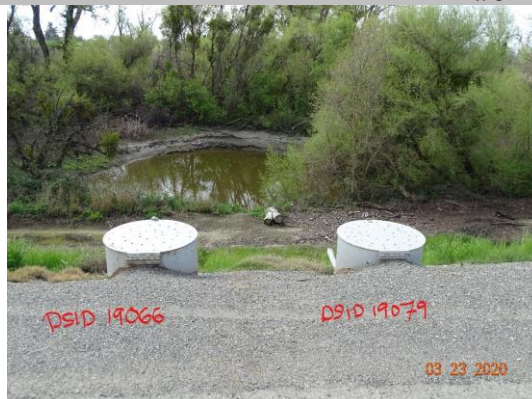
Photo 2 of 3 : UCIP_SP_2020_56577_83683.jpg

WS view: Siphon breaker and air vent.

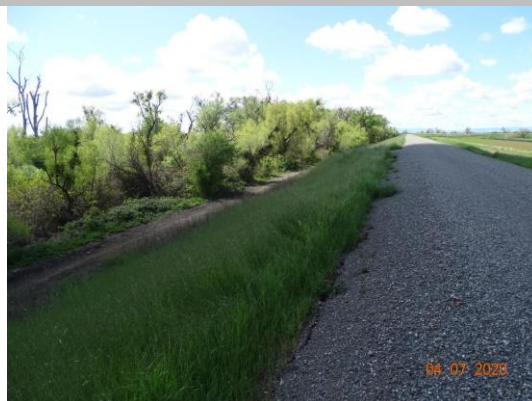
Photo 1 of 1 : SP_2020_ST0008_284_8_20200409_00014.jpg

View of vegetation on the waterside slope. Spring 2020.

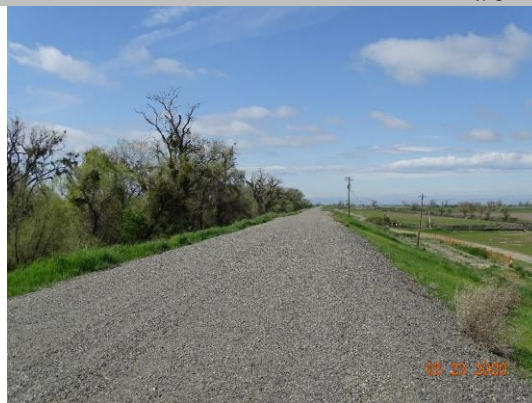
Photo 1 of 3 : UCIP_SP_2020_56650_83691.jpg

Comment Code					
Inspector Comment					
DS_ID:19067 FS_ID:56650 EP_NO: 17497 Repair Type: Non-Urgent Crossing Status: Indicator Found UCIP Comments: 03/23/2020 No issues observed during inspection. Record upgraded to Non-Urgent due to missing maintenance and performance records. Recommend placing additional pipeline marks closer to the levee shoulder. Crossing is subject to relocation within the next 1 – 2 years due to the upcoming Lower Elkhorn Basin Levee Setback (LEBLS) Project. (S. Donovan - DWR UCIP)10/04/2012 Marker found on landside of the levee. (P. Amatya - DWR UCIP) FIELD_STRUCT_DESC: 12-inch steel jet fuel pipeline bored under the Sacramento River, Sacramento Bypass, and their levees, at an unknown depth. Markers found on the landside (LS) of the levee. (12-inch pipeline authorized under Permit No. 17497, 2003 - Wickland Pipelines LLC). (Realignment of portion of pipeline due to the Lower Elkhorn Basin Levee Setback Project is authorized under Permit No. 17497-1, 2019 - Wickland Pipelines LLC). FS Date: 3/23/2020 2:33:00 PM

Overview of the levee crown looking d/s.

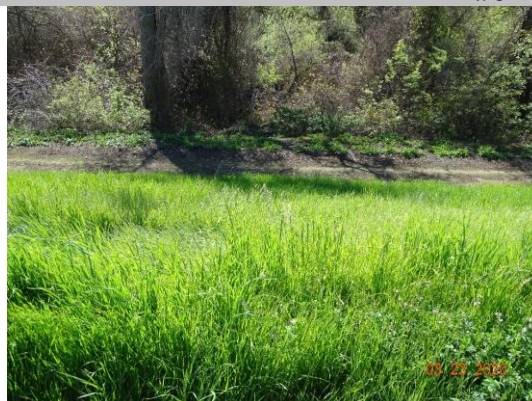
Photo 2 of 3 : UCIP_SP_2020_56650_83692.jpg

WS view: Looking down the levee slope.

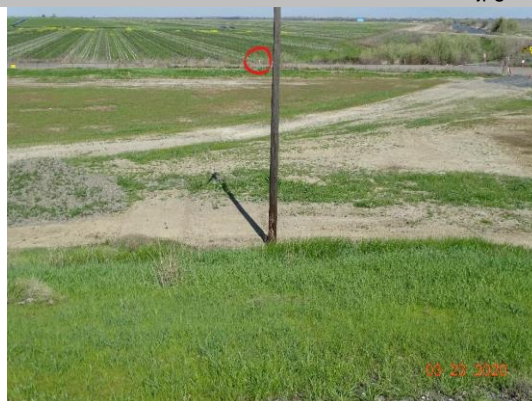
Photo 3 of 3 : UCIP_SP_2020_56650_83693.jpg

LS view: Looking down the levee slope with petroleum pipeline marker in the background.

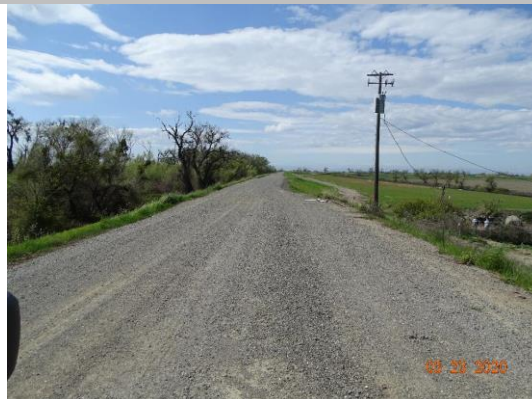
Photo 1 of 1 : UCIP_SP_2020_56651_83698.jpg

Comment Code						
Inspector Comment						
DS_ID:19075						
FS_ID:56651						
EP_NO: N/A						
Repair Type: Non-Urgent						
Crossing Status: Not Found						
UCIP Comments: 03/23/2020 Record is Non-Urgent. No permit found authorizing crossing. Geophysical study (07-20-2018) found no evidence of the pipe. This is possibly the pipe that was authorized to be replaced by three 20-inch pipes in 1960 under Permit No. 3259. The 30-in pipe was supposed to be capped on both ends and completely filled by grouting. Need further investigation. Crossing is subject to relocation within the next 1 – 2 years due to the upcoming Lower Elkhorn Basin Levee Setback (LEBLS) Project. (S. Donovan - DWR UCIP)						
FIELD_STRUCT_DESC: 30-inch corrugated metal (CM) drainage pipe, invert elevation: 13.7 feet. [Additional References: USACE Sacramento O&M Manual 122 - North Levee of Sacramento Bypass - Part 1, August 1955, revised 29 December 2016 (RM 178), USACE As-Built Drawing No. 50-10-2796, Sheets 2 and 3 pdf file, April 1951, (Replacement of existing 30-inch pipe [HLM 1.30] authorized under Permit No. 3259, 1960 - Reclamation District No. 785)].

Overview of the levee crown at assumed location of crossing looking d/s.

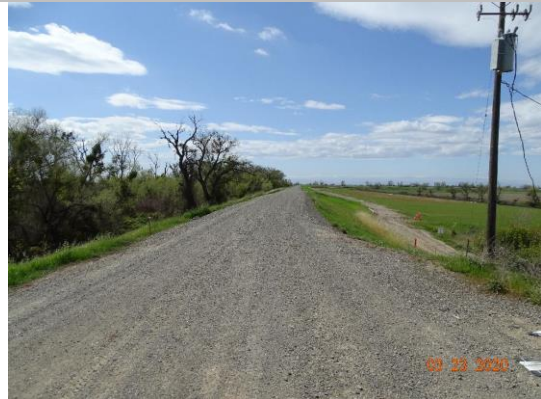
Photo 1 of 1 : UCIP_SP_2020_56673_83700.jpg

Comment Code						
Inspector Comment						
DS_ID:19085 FS_ID:56673 EP_NO: N/A Repair Type: Non-Urgent Crossing Status: Not Found UCIP Comments: 03/23/2020 Record is Non-Urgent. No permit found authorizing crossing. No evidence of pipe found during inspection. Crossing is subject to relocation within the next 1 – 2 years due to the upcoming Lower Elkhorn Basin Levee Setback (LEBLS) Project. (S. Donovan - DWR UCIP) FIELD_STRUCT_DESC: 2 of 3: 14-inch steel drainage pipe through the levee, at an unknown depth. Pump on the landside (LS). [Additional References: USACE Sacramento O&M Manual Unit 122 - North Levee of Sacramento Bypass - Part 1, August 1955, revised 29 December 2016 (RM 179), USACE As-Built Drawing No. 50-10-2796, Sheets 2 and 3 pdf file, April 1951, DWR Levee Log, 2004 (HLM 1.30)]. FS Date: 3/23/2020 8:46:00 AM

Overview of the levee crown at assumed location of crossing looking d/s.

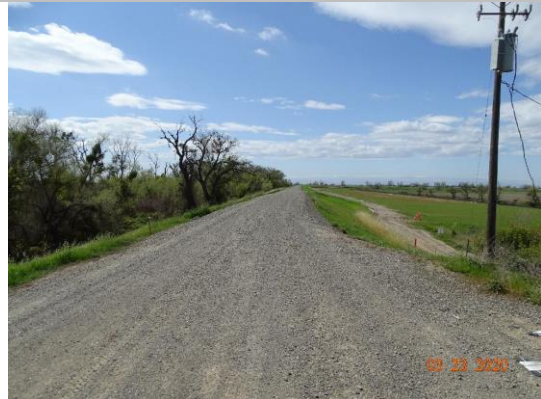
Photo 1 of 1 : UCIP_SP_2020_56652_83699.jpg

Comment Code						
Inspector Comment						
DS_ID:19074 FS_ID:56652 EP_NO: N/A Repair Type: Non-Urgent Crossing Status: Not Found UCIP Comments: 03/23/2020 Record is Non-Urgent. No permit found authorizing crossing. No evidence of pipe found during inspection. Crossing is subject to relocation within the next 1 – 2 years due to the upcoming Lower Elkhorn Basin Levee Setback (LEBLS) Project. (S. Donovan - DWR UCIP) FIELD_STRUCT_DESC: 1 of 3: 14-inch steel drainage pipe through the levee, at an unknown depth. Pump on the landside (LS). [Additional References: USACE Sacramento O&M Manual Unit 122 - North Levee of Sacramento Bypass - Part 1, August 1955, revised 29 December 2016 (RM 179), USACE As-Built Drawing No. 50-10-2796, Sheets 2 and 3 pdf file, April 1951, DWR Levee Log, 2004 (HLM 1.30)]. FS Date: 3/23/2020 3:27:00 PM

Overview of the levee crown at assumed location of crossing looking d/s.

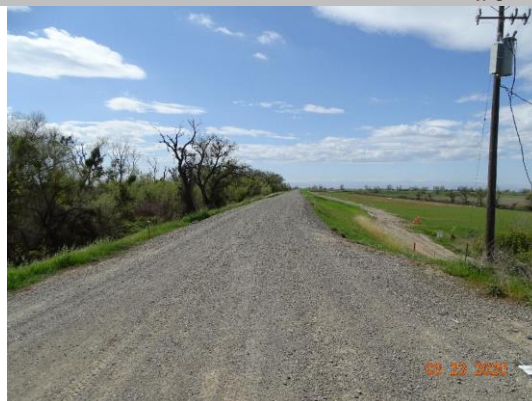
Photo 1 of 3 : UCIP_SP_2020_56661_83855.jpg

DS_ID:813
FS_ID:56661
EP_NO: 16279
Repair Type: Non-Urgent
Crossing Status: Found
UCIP Comments: 03/23/2020 Record upgraded to Non-Urgent due to erosion of the WS levee slope around and below the riser. Some cobble rock protection present. Recommend further erosion repair. Crossing is subject to relocation within the next 1 – 2 years due to the upcoming Lower Elkhorn Basin Levee Setback (LEBLS) Project. (S. Donovan - DWR UCIP)10/04/2012 Found remains of concrete headwall and concrete box on the landside of the levee. Also found a flap gate cover on the WS berm. (P. Amatya - DWR UCIP)
FIELD_STRUCT_DESC: 1 of 3: 20-inch coated steel drainage pipe through the levee, 5.7 feet below the crown. Vertical pump unit on the landside (LS). Metal cutoff wall installed. Siphon breaker on the waterside (WS) shoulder. Vertical galvanized iron pipe trash rack on the inlet of the pumping plant. (20-inch pipe authorized under Permit No. 3259, 1960 - Reclamation District No. 785. 20-inch pipe [HLM 1.30] replaced under Permit No. 16279, 1994 - Reclamation District No. 785). [Additional Reference: DWR Levee Log, 2004 (HLM 1.30)].

Overview of the levee crown looking d/s.

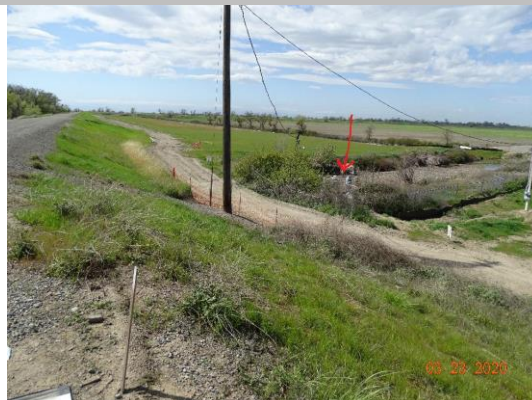
Photo 2 of 3 : UCIP_SP_2020_56661_83856.jpg

LS view: Overview and pumpstation.

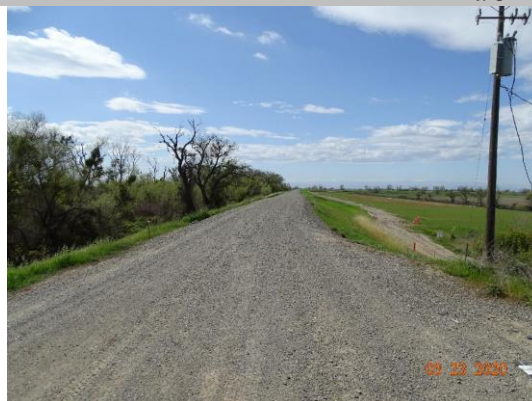
Photo 1 of 3 : UCIP_SP_2020_56662_83714.jpg

Comment Code						
Inspector Comment						
DS_ID:19080 FS_ID:56662 EP_NO: 16279 Repair Type: Non-Urgent Crossing Status: Found UCIP Comments: 03/23/2020 Record upgraded to Non-Urgent due to erosion of the WS levee slope around and below the riser. Some cobble rock protection present. Recommend further erosion repair. Crossing is subject to relocation within the next 1 – 2 years due to the upcoming Lower Elkhorn Basin Levee Setback (LEBLS) Project. (S. Donovan - DWR UCIP)10/04/2012 Found remaining of concrete headwall and a concrete box on landside of the levee. (P. Amaty - DWR UCIP) FIELD_STRUCT_DESC: 2 of 3: 20-inch coated steel drainage pipe through the levee, 5.7 feet below the crown. Vertical pump unit on the landside (LS). Metal cutoff wall installed. Siphon breaker on the waterside (WS) shoulder. Vertical galvanized iron pipe trash rack on the inlet of the pumping plant. (20-inch pipe authorized under Permit No. 3259, 1960 - Reclamation District No. 785. 20-inch pipe [HLM 1.30] replaced under Permit No. 16279, 1994 - Reclamation District No. 785). [Additional Reference: DWR Levee Log, 2004 (HLM 1.30)]. FS Date: 3/23/2020 12:19:00 PM

Overview of the levee crown looking d/s.

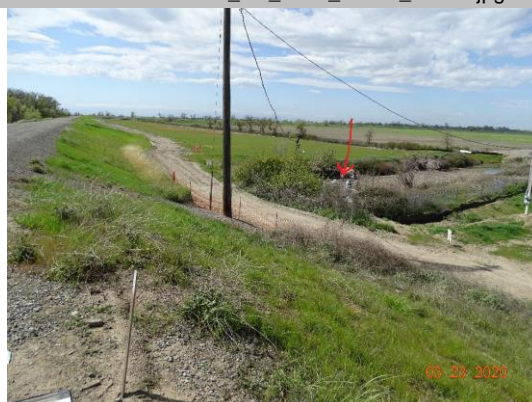
Photo 2 of 3 : UCIP_SP_2020_56662_83715.jpg

LS view: Overview and pump station.

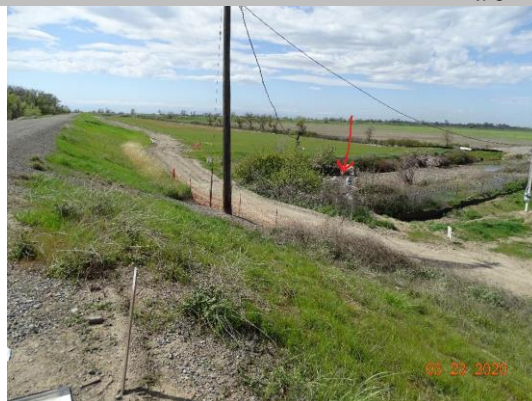
Photo 2 of 3 : UCIP_SP_2020_56663_83729.jpg

LS view: Overview and pump station.

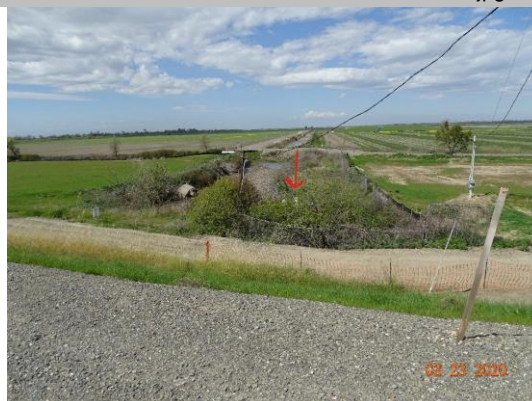
Photo 3 of 3 : UCIP_SP_2020_56663_83731.jpg

LS view: Levee slope and pump station.

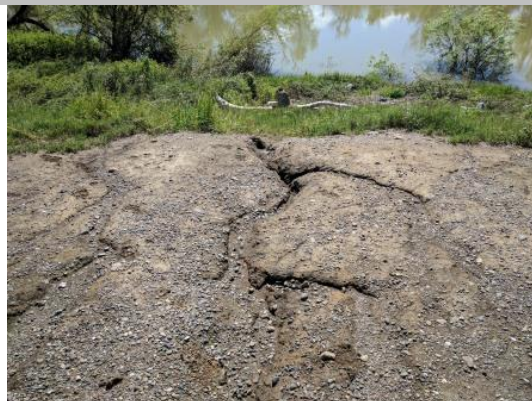
Photo 1 of 1 : SP_2020_ST0008_284_15_20200228_00004.jpg

LM Start	1.74	Rating **	A/W	Issue No.	15
LM End	1.74	Issue Type +	Ma	Location *	WS
Category	Earthen Levee			GPS Latitude/Longitude	
				Start	End
Item	Erosion / Bank Caving			38.599546 °	38.599546 °
				-121.590235 °	-121.590235 °
DWR ID	DWR_ST0008_01_s_2018_15				
Comment Code					
E1 : Note and monitor erosion site.					
Inspector Comment					
There is runoff erosion on the oversized levee section located on the waterside levee slope. Recommend monitoring.

View of erosion on waterside slope. Spring 2017.

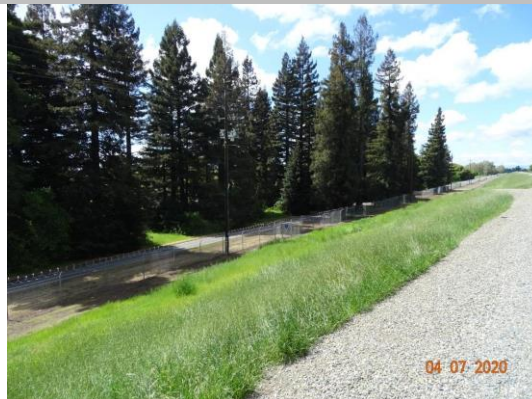
Photo 1 of 1 : SP_2020_ST0008_285_1_20200409_00002.jpg

View of vegetation on the landside slope. Spring 2020.

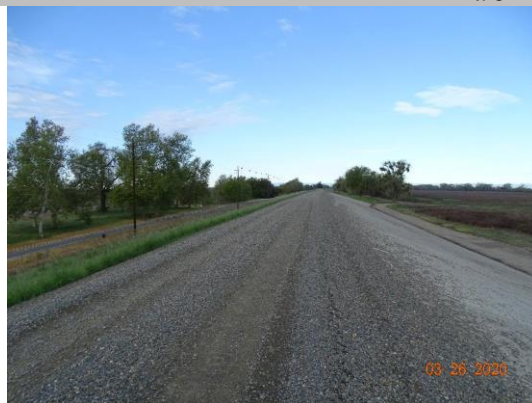
Photo 1 of 3 : UCIP_SP_2020_56664_83748.jpg

LM Start	0.38	Rating **	M	Issue No.	9
LM End	0.38	Issue Type +	En	Location *	
Category	Supplemental			GPS Latitude/Longitude	
				Start	End
Item	DWR UCIP Field Study			38.600985 °	38.600985 °
				-121.562216 °	-121.562216 °
DWR ID	25124				
Comment Code					
Inspector Comment					
DS_ID:25124 FS_ID:56664 EP_NO: N/A Repair Type: Non-Urgent Crossing Status: Not Found UCIP Comments: 3/26/2020 Record is Non-Urgent. No evidence of pipe found. Per Permit No. 7689, pipe was properly removed in 1972. Record is inactive. (S. Donovan - DWR UCIP) FIELD_STRUCT_DESC: *REMOVED* 18-inch dredge pipe of unknown material through the levee crown at 2 feet depth. (18-inch dredge pipe [HLM 0.38] authorized under Permit No. 7689, 1971 - Shellmaker, Inc.). FS Date: 3/26/2020 1:31:00 PM

Overview of the levee crown at assumed location of crossing looking d/s.

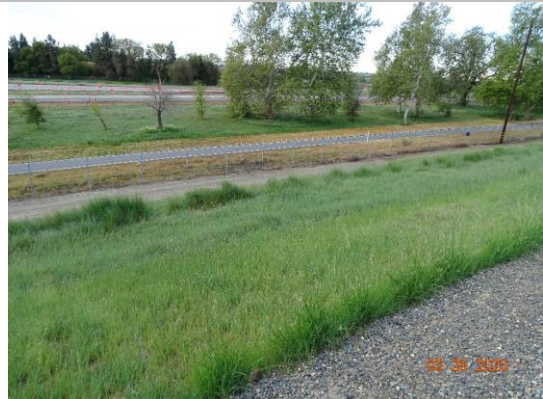
Photo 2 of 3 : UCIP_SP_2020_56664_83749.jpg

LS view: Overview of the levee slope at assumed location of crossing.

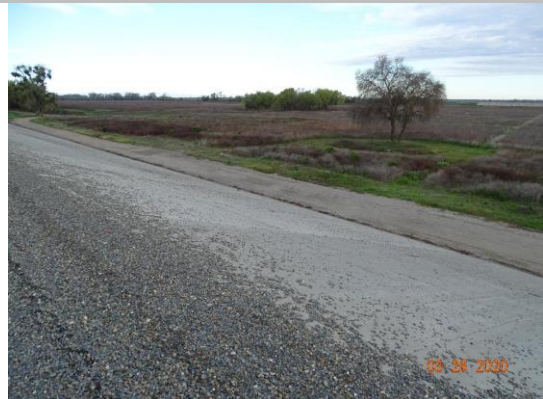
Photo 3 of 3 : UCIP_SP_2020_56664_83750.jpg

WS view: Overview of the levee slope at assumed location of crossing.

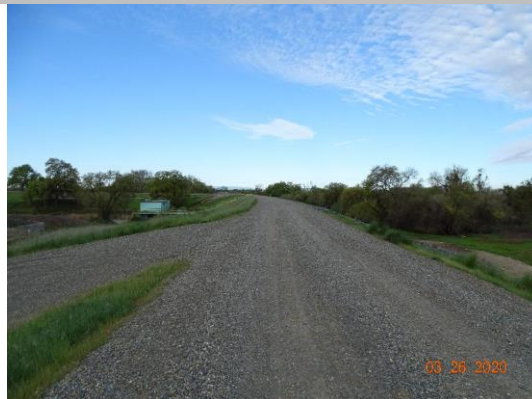
Photo 1 of 1 : UCIP_SP_2020_56668_83757.jpg

Comment Code						
Inspector Comment						
DS_ID:815 FS_ID:56668 EP_NO: 7616 Repair Type: Non-Urgent Crossing Status: Not Found UCIP Comments: 03/26/2020 Record upgraded to Non-Urgent due to conflicting location information. Recommend contacting owner for clarification. No evidence of pipe found during inspection. (S. Donovan - DWR UCIP) FIELD_STRUCT_DESC: 1.5-inch conduit (telephone) through the levee, 2 feet below the levee crown. (Telephone conduit [HLM 1.19] authorized under Permit No. 7616, 1971 - Pacific Telephone and Telegraph Company (PT&T). Renewal of Permit No. 7616 authorized under Permit No. 7616-A, 1973 - PT&T). [Additional Reference: DWR Levee Log, 2004 (HLM 1.17)]. FS Date: 3/26/2020 2:27:00 PM

Overview of the levee crown at assumed location of crossing looking d/s.

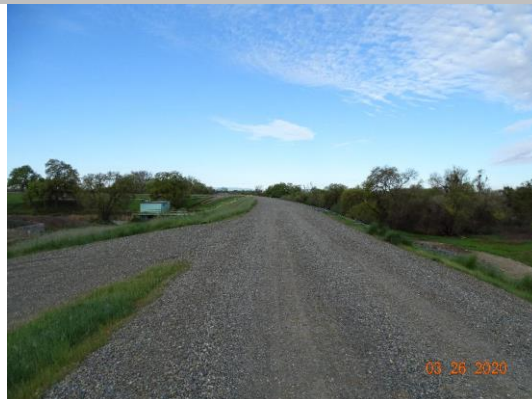
Photo 1 of 1 : UCIP_SP_2020_56659_83758.jpg

LM Start	1.18	Rating **	M	Issue No.	11	
LM End	1.18	Issue Type +	En	Location *		
Category	Supplemental			GPS Latitude/Longitude		
				Start		End
Item	DWR UCIP Field Study			38.597620 °		38.597620 °
				-121.576280 °		-121.576280 °
DWR ID	816					
Comment Code						
Inspector Comment						
DS_ID:816 FS_ID:56659 EP_NO: N/A Repair Type: Non-Urgent Crossing Status: Not Found UCIP Comments: 03/26/2020 Record upgraded to Non-Urgent. Geophysical study (07-20-2018) found no evidence of the pipe. (S. Donovan - DWR UCIP) FIELD_STRUCT_DESC: 30-inch concrete culvert through the levee, 23.5 feet below the crown. A 24-inch pipe is sleeved through the 30-inch culvert with the annular space concrete grouted. A screw gate is in the concrete well on the waterward (WS) shoulder. [Additional Reference: DWR Levee Log, 2004 (HLM 1.18)]. FS Date: 3/26/2020 2:33:00 PM

Overview of the levee crown at assumed location of crossing looking d/s.

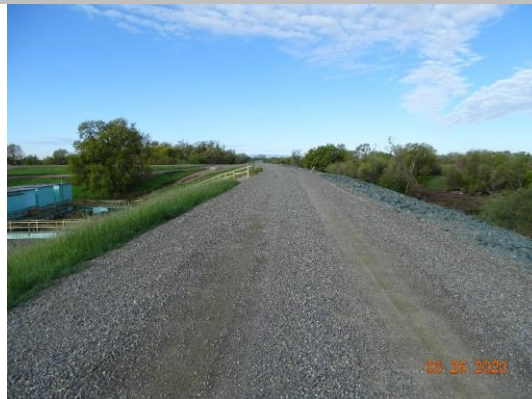
Photo 1 of 3 : UCIP_SP_2020_56660_83761.jpg

DS_ID:19071
FS_ID:56660
EP_NO: 14082
Repair Type: Non-Urgent
Crossing Status: Found
UCIP Comments: 03/26/2020 Record remains No Action Needed.
Unable to verify presence of flap gate because discharge end submerged. Otherwise, no issues observed during inspection. (S. Donovan - DWR UCIP)10/04/2012 Vertical GI pipe trash rack in inlet structure. Big pumping plant with 5 pipes. (P. Amatya - DWR UCIP) FIELD_STRUCT_DESC: [Reclamation District No. 537 Drainage Pump Station] 1 of 3: 42-inch coated steel drainage pipe through the levee, 2.8 feet below the crown. Pumping plant located 20 feet off the landside (LS) toe. Air release valve on the LS shoulder. Flap gate on the discharge end of the pipeline. Cutoff wall around pipes at levee center line. Walkway on the LS of the levee. Transformer on fill on the LS, 50 feet downstream of pump station, with underground electrical extension to pump station. (42-inch pipe [HLM 1.19 - HLM 1.23] authorized under Permit No. 14082, 1985 - Kaiser Development Company).

Overview of the levee crown looking d/s.

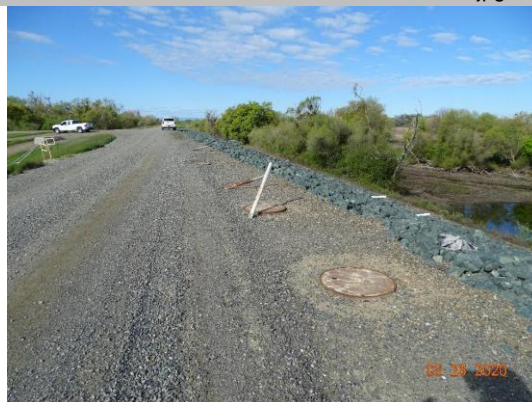
Photo 2 of 3 : UCIP_SP_2020_56660_83759.jpg

WS view: Overview of the levee slope and siphon breaker.

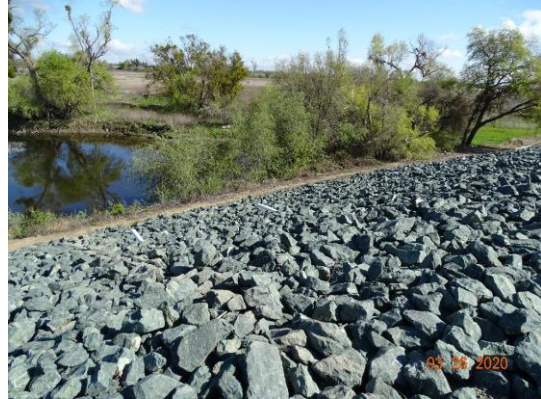
Photo 2 of 3 : UCIP_SP_2020_56625_83791.jpg

WS view: Looking down the levee slope.

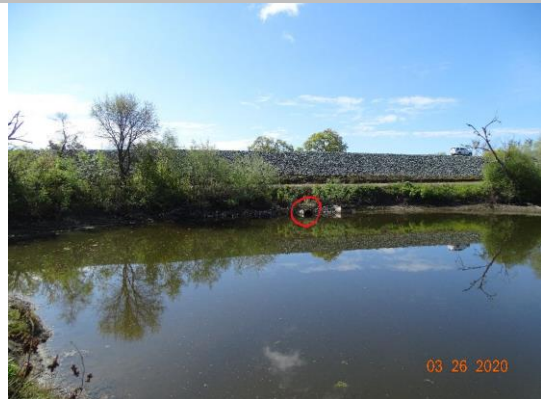
Photo 3 of 3 : UCIP_SP_2020_56625_83792.jpg

WS view: Partially submerged pipe outlet with missing flap gate and overview of the levee slope.

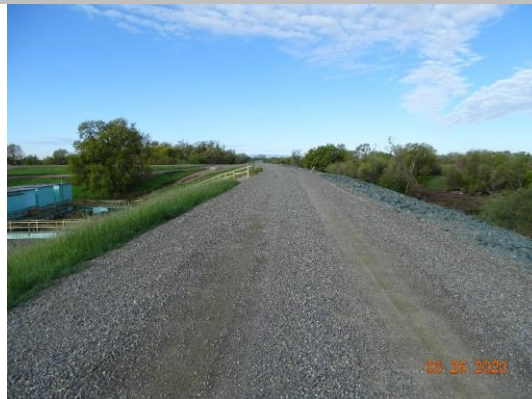
Photo 1 of 3 : UCIP_SP_2020_56626_83802.jpg

DS_ID:818
FS_ID:56626
EP_NO: 2930
Repair Type: Non-Urgent
Crossing Status: Found
UCIP Comments: 03/26/2020 Record upgraded to Non-Urgent due to the flap gate not fully closing. Need to investigate the actual depth of crossing due to conflicting information in the record sources. Crossing appears to be installed at an elevation higher than 23.5 feet below the crown. (S. Donovan - DWR UCIP)10/04/2012 Vertical GI pipe trash rack in inlet structure. Big pumping plant with 5 pipes. (P. Amatya - DWR UCIP)
FIELD_STRUCT_DESC: [Reclamation District No. 811 Drainage Pumping Plant] 42-inch drainage pipe through the levee, 23.5 feet below the crown. Pumping plant on a pipe structure in the drainage ditch on the landside (LS). Metal stairway on the LS slope to the pumping plant. Siphon breaker in an 18-inch corrugated metal pipe (CMP) riser on the LS slope. Flap gate on the waterside (WS) end. Cutoff wall around pipe at levee center line. (42-inch steel pipe [HLM 1.20] and pumping plant authorized under Permit No. 2930, 1958 - Reclamation District No. 811. Stairway to pumping plant authorized under Permit No. 3056, 1959 - Reclamation District No. 811).

Overview of the levee crown looking d/s.

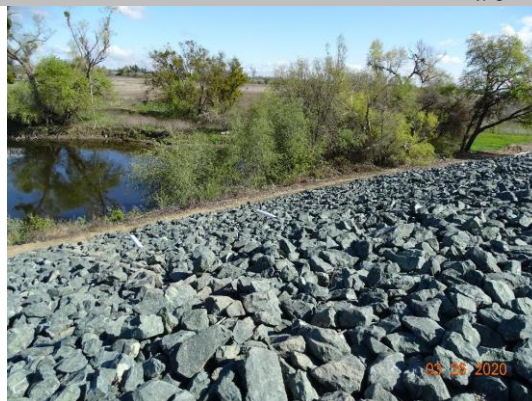
Photo 2 of 3 : UCIP_SP_2020_56626_83803.jpg

WS view: Looking down the levee slope.

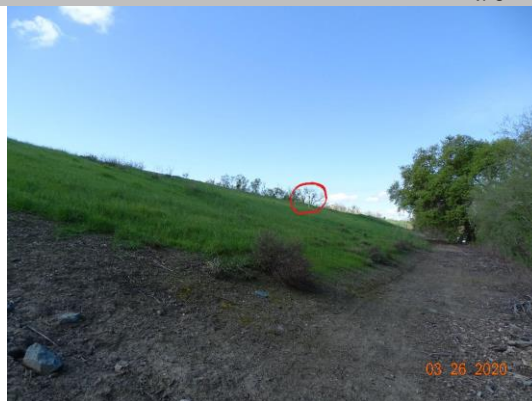
Photo 2 of 3 : UCIP_SP_2020_56638_83815.jpg

WS view: Overview of the levee slope with petroleum pipeline marker.

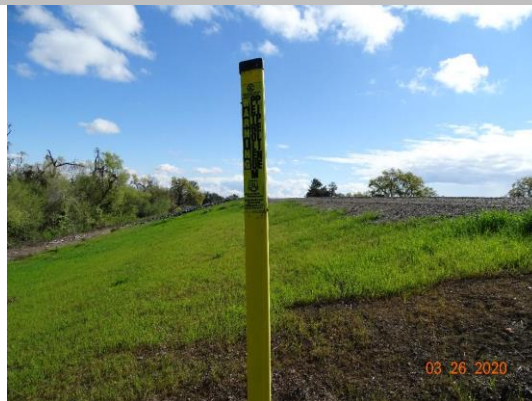
Photo 3 of 3 : UCIP_SP_2020_56638_83816.jpg

WS view: Overview of the levee slope with petroleum pipeline marker.

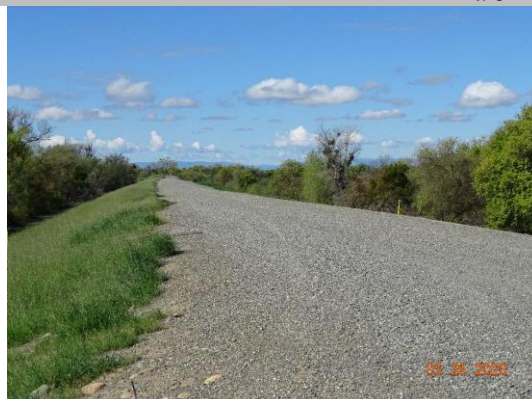
Photo 1 of 1 : UCIP_SP_2020_56633_83825.jpg

Comment Code						
Inspector Comment						
DS_ID:19078 FS_ID:56633 EP_NO: N/A Repair Type: Non-Urgent Crossing Status: Not Found UCIP Comments: 03/26/2020 Record is Non-Urgent. No evidence of pipe found during inspection. Geophysical study for nearby DSID 19077 (07-20-2018) found no evidence of a crossing at the site. No As-Built drawing found. (S. Donovan - DWR UCIP) FIELD_STRUCT_DESC: [Reclamation District No. 537 Drainage Pumping Plant] 2 of 2: 30-inch drainage pipe of an unknown material through the levee, at an unknown depth. Screw gate in a concrete well on the waterside (WS). Pumping plant on the landside (LS). [Additional Reference: USACE Sacramento O&M Manual, Unit 116, August 1955, listed as 30-inch drainage pipe]. FS Date: 3/26/2020 2:50:00 PM

Overview of the levee crown at assumed crossing location looking d/s.

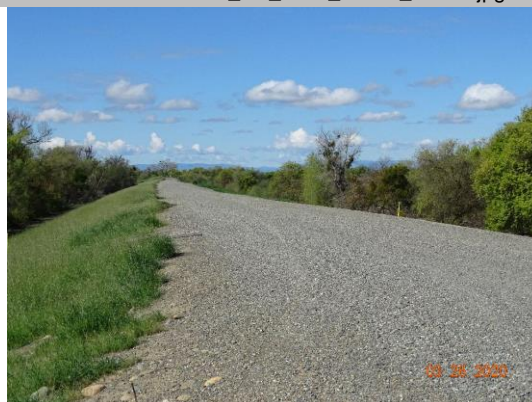
Photo 1 of 1 : UCIP_SP_2020_56631_83824.jpg

Comment Code					
Inspector Comment					
DS_ID:19077 FS_ID:56631 EP_NO: N/A Repair Type: Non-Urgent Crossing Status: Not Found UCIP Comments: 03/26/2020 Record upgraded to Non-Urgent. Geophysical study (07-20-2018) found no evidence of the pipe. No As-Built drawing found. (S. Donovan - DWR UCIP) FIELD_STRUCT_DESC: [Reclamation District No. 537 Drainage Pumping Plant] 1 of 2: 30-inch drainage pipe of an unknown material through the levee, at an unknown depth. Screw gate in a concrete well on the waterside (WS). Pumping plant on the landside (LS). [Additional Reference: USACE Sacramento O&M Manual, Unit 116, August 1955, listed as 30-inch drainage pipe]. FS Date: 3/26/2020 2:47:00 PM

Overview of the levee crown at assumed crossing location looking d/s.

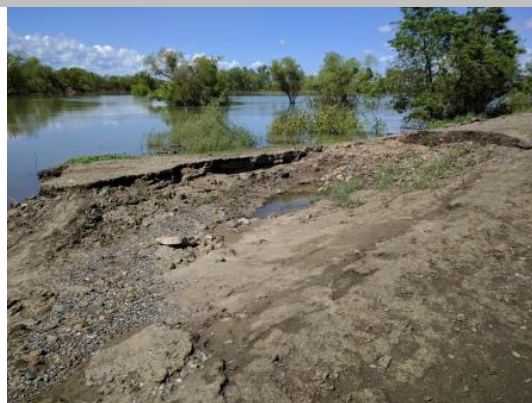
Photo 1 of 1 : SP_2020_ST0008_285_8_20200228_00001.jpg

LM Start	1.77	Rating **	A/W	Issue No.	8
LM End	1.77	Issue Type +	Ma	Location *	WS
Category	Earthen Levee			GPS Latitude/Longitude	
				Start	End
Item	Erosion / Bank Caving			38.594710 °	38.594710 °
				-121.586582 °	-121.586582 °
DWR ID	DWR_ST0008_02_s_2019_8				
Comment Code					
E1 : Note and monitor erosion site.					
Inspector Comment					
This is a runoff location, but it is not within the levee prism. Recommend monitoring.

View of erosion on waterside levee slope. Spring 2017.
